# Manhole Inspection Summary

Manhole # S23OO1006MH

**Location** Address: **214 RIDGEWOOD RD**

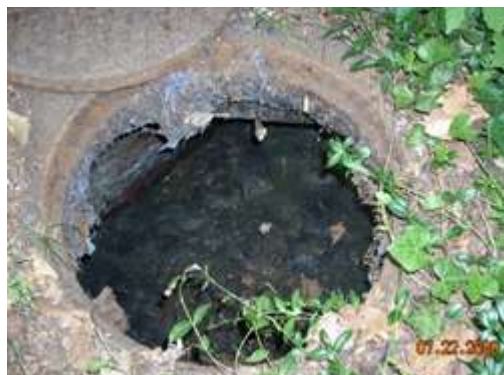
Top View

Evidence of surcharge - Bench debris.  
Channel debris.

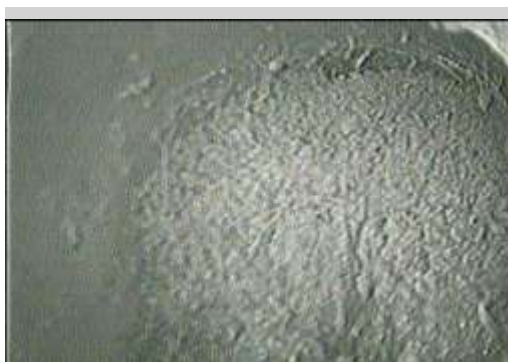
Inside the I6

Root intrusion/ball.

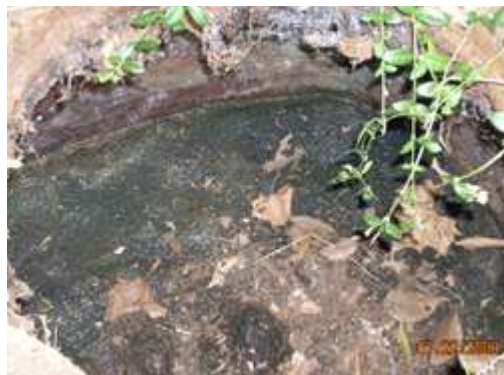
Defect

Corbel deterioration, root intrusion and  
infiltration. Barrel infiltration - other side.

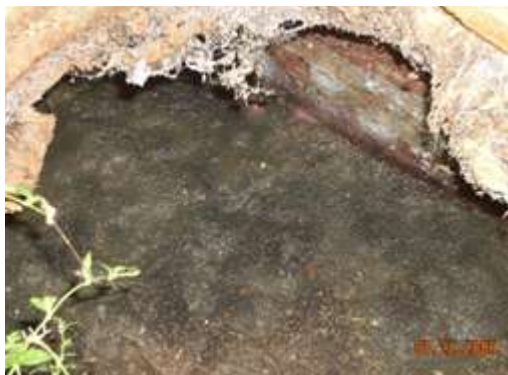
Defect

Corbel deterioration, root intrusion and  
infiltration. Barrel infiltration.

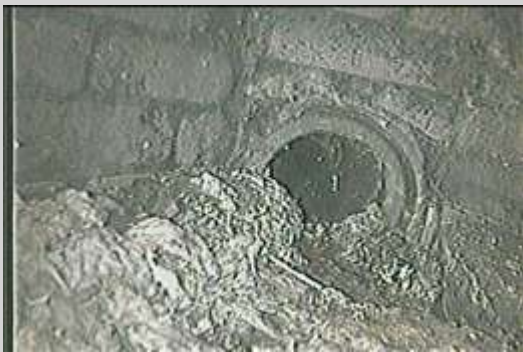
### 6 in. Circular Gravity Sewer Pipe Out @ 12 O'Clock

Deposits: ☐ None ☒ **Mud** ☐ Sludge ☒ **Debris** ☒ **Grease**

Silt Depth: **2** (in.) Deposits Extent: **Light**

Infiltration: **Evidence** Pipe Seal Cond: **Unknown**

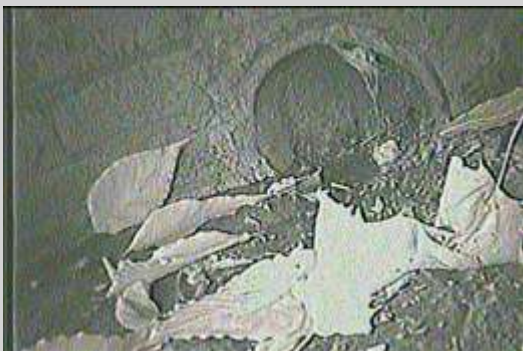
### 6 in. Circular Gravity Sewer Pipe In @ 6 O'Clock

Deposits: ☐ None ☒ **Mud** ☐ Sludge ☒ **Debris** ☐ **Grease**

Silt Depth: **1** (in.) Deposits Extent: **Light**

Infiltration: **Evidence** Pipe Seal Cond: **Roots**

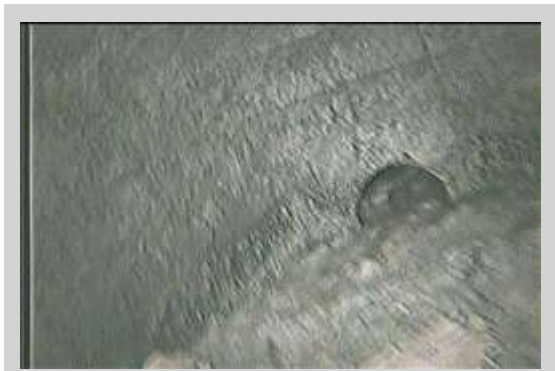
6 in. Circular Gravity Sewer  
Pipe In @ 9 O'Clock

Barrel root intrusion and infiltration.

Deposits: ☐ None ☒ **Mud** ☐ Sludge ☒ **Debris** ☒ **Grease**

Silt Depth: **3** (in.) Deposits Extent: **Medium**
